"Full" Reserve Study

Pueblo at Andersen Springs Chandler, AZ

Report #: 13318-0

Date Prepared: January 28, 2018

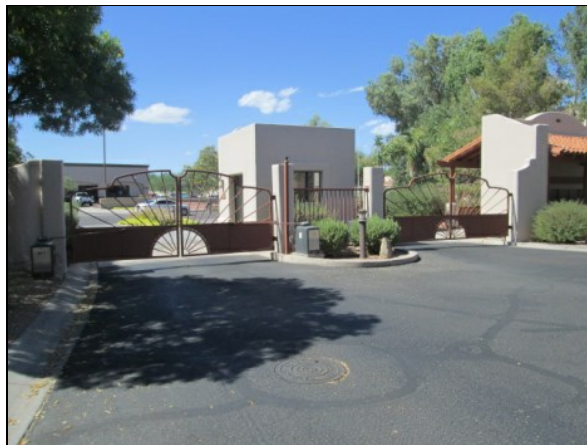
Evaluation: This component accounts for (4) 8' metal vehicle gates, 7 LF of metal fence between the gates, and (1) pedestrian access gate at the mailboxes. Gates appear to be in good condition. No signs of damage or abuse. Long life expectancy under normal circumstances. Replacement should still be anticipated eventually to update and modernize the gates.

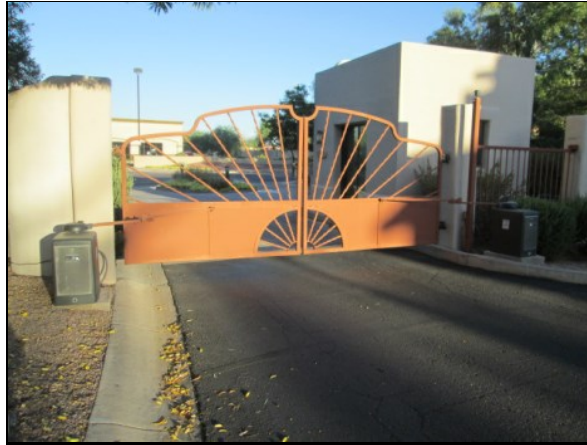
Evaluation: Gates were painted shortly after our inspection. Surfaces are expected to be in good condition. They have high visibility and should be repainted regularly to maintain the appearance.

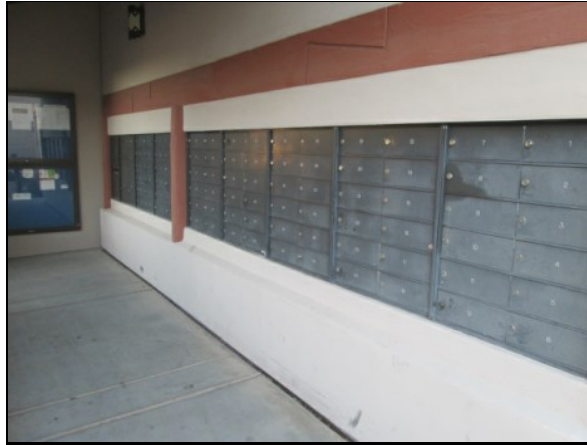
Evaluation: Mailbox clusters appear faded and weathered though functional. They are pretty well protected under roof cover.
Treat repairsUseful Life:
25 yearsRemaining Life:
5 years

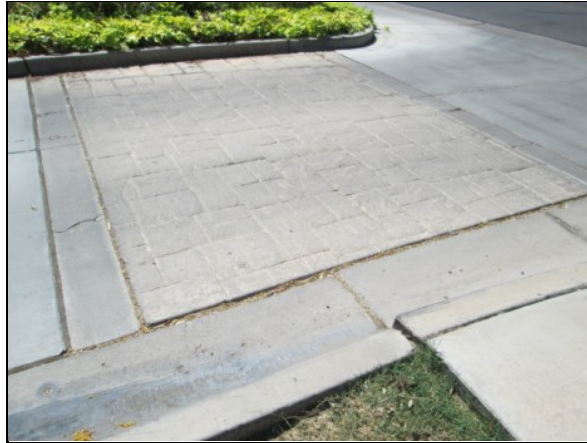
Evaluation: Stamped concrete appears older and shows signs of wear. Due to significant vehicle traffic, replacement of this decorative concrete should be expected at some point in the future. Recommend coordinating with repaving the asphalt.

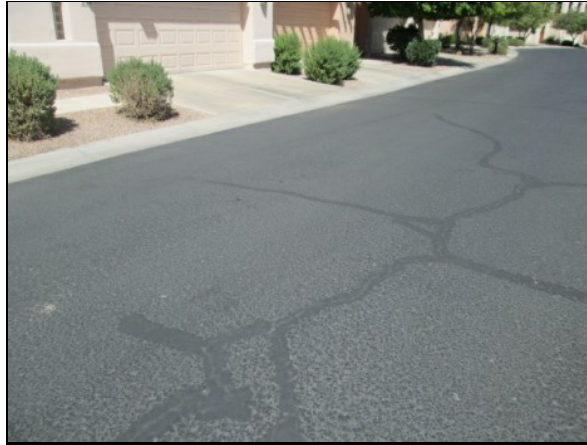
Evaluation: Larger cracks appear well sealed. They will continue to open, and new cracks will develop. This component funds an allowance to seal cracks between surface sealing intervals.

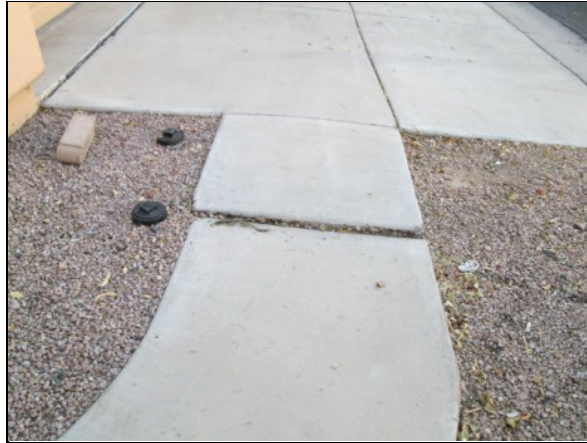
Evaluation: Issues were reported with curbing. Some lifted sidewalks were noted too. There is no expectancy to completely replace the concrete. This component funds an allowance for periodic repairs and/or partial replacements as needed.

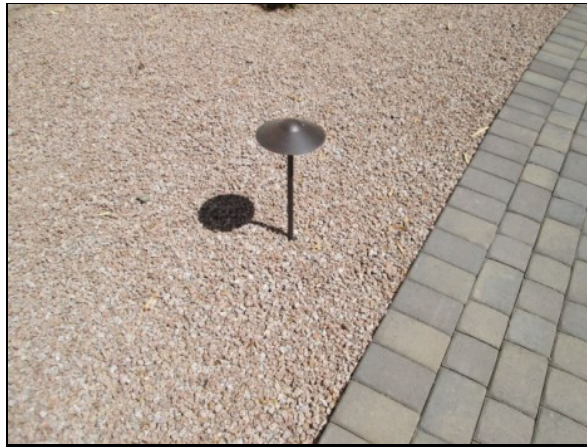
Evaluation: Path lights are decorative and in good condition. As more walkways are added as part of the upcoming water feature renovation projects, more lighting is likely to be added/replaced as well.

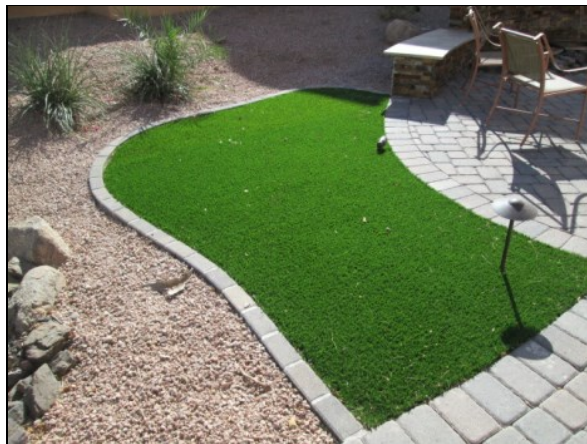
Evaluation: Turf still looks near new and is in good shape. Future replacement should be expected.

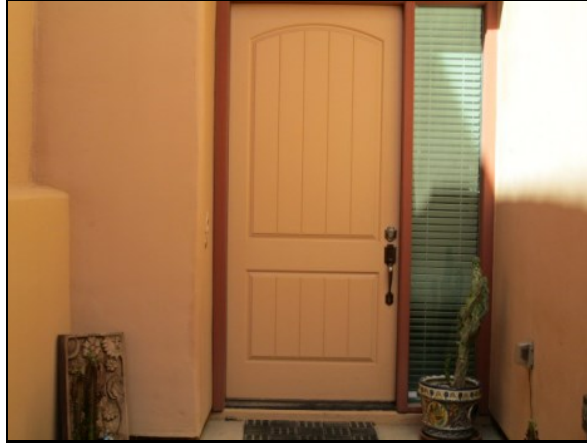
Evaluation: Quantity includes (84) unit front doors, (128) hinged patio doors, and (4) pool building doors. HOA is reportedly responsible for these doors. Long life expectancy under normal circumstances. Still appear to be in good shape, and no problems were reported. Replacement should be planned eventually.

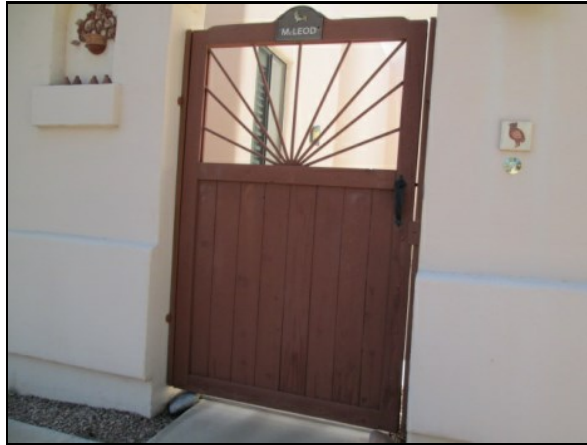
Evaluation: Wood patio gate appear to be decorative and in good shape overall. Some of them have reportedly been replaced, but most are still original. Replacement should be planned eventually. Painting is included with the building wood surfaces.

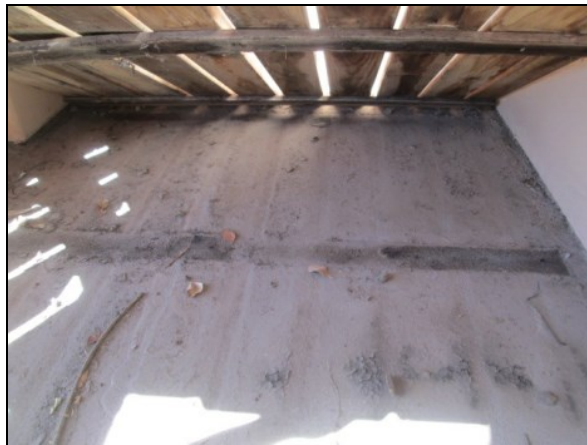
Evaluation: Balcony decks vary in shape and size; we estimated total surface area of ~10,800 sq ft. Primarily still original. They have a roofing material under a wood structure. A few decks have been rebuilt, but the location, timing, and cost of that work is currently unknown. Rebuild is being phased over multiple years to spread the cost over more time. Depending on the type of new deck installed, the useful may change and more frequent maintenance work might be needed as well.
