Update "With-Site-Visit" Reserve Study

Windmill Village HOA Buckeye, AZ

Report #: 19866-1
For Period Beginning: January 1, 2021
Expires: December 31, 2021

Date Prepared: December 2, 2020

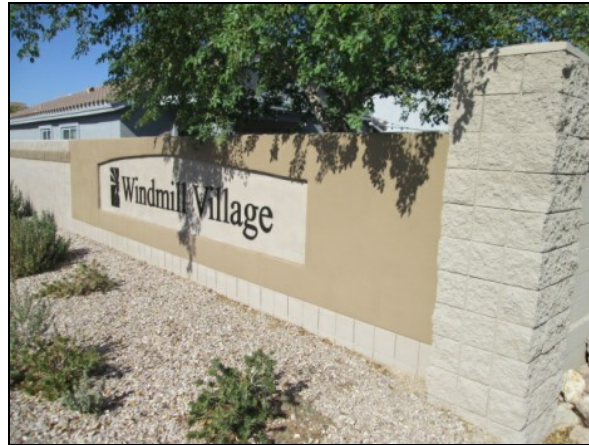
Useful Life:
20 years

Remaining Life:
16 years

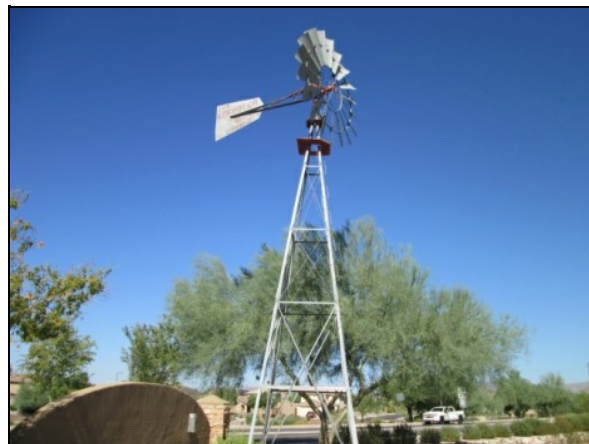
Comp #: 110 Windmill - Replace**Quantity: (1) Windmill**

Funded?: No. This component has an extended life span with no expectancy to replace in the foreseeable future.

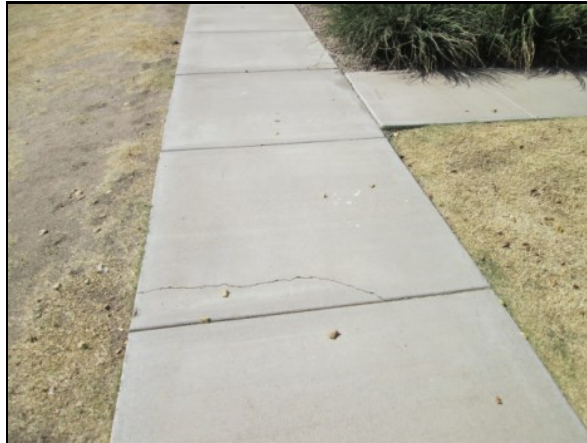
Useful Life:
5 years

Remaining Life:
0 years

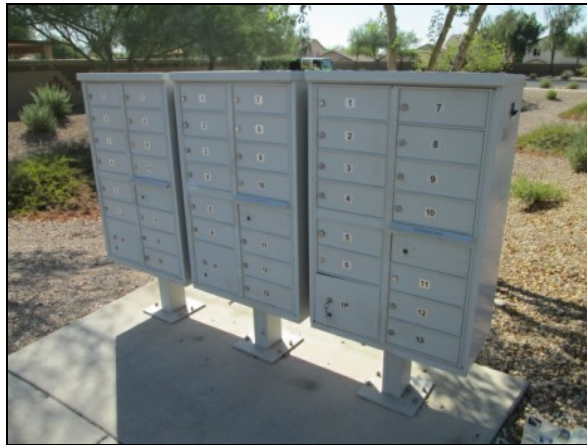
Useful Life:
20 years

Remaining Life:
5 years

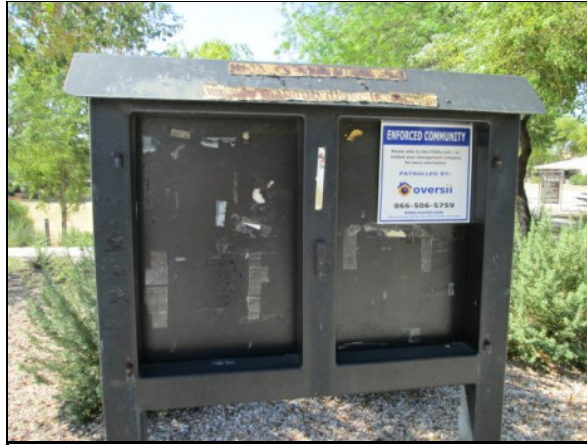
Useful Life:
10 years

Remaining Life:
0 years
