Wayne Ranch HOA

Regarding: FY2016 - Level I Capital Replacement Reserve Study

| Location: San Tan Valley, Arizona | Type of Study Level I Reserve Study | Date Prepared August 24, 2015 |

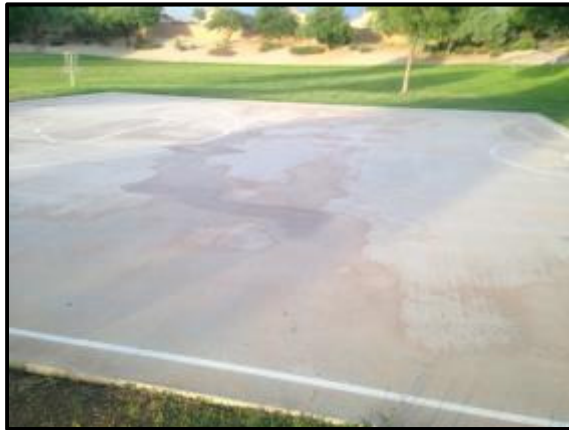
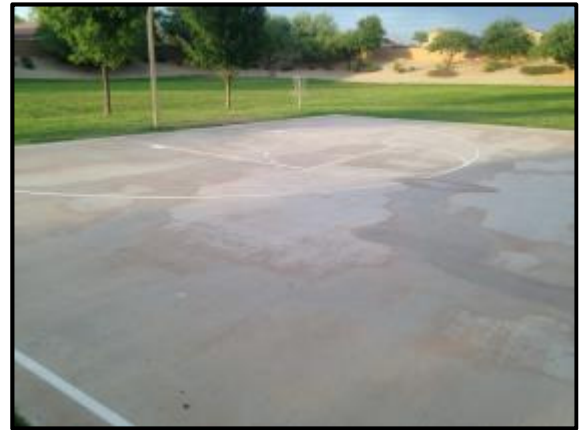
Concrete - Repairs

Age – Construction on this community began during late 2004 early 2005. We are using 2005 as the average installation date of concrete surfaces.

Condition - During our onsite visit, we noted good to fair conditions of the basketball courts, sidewalks and concrete curbing.

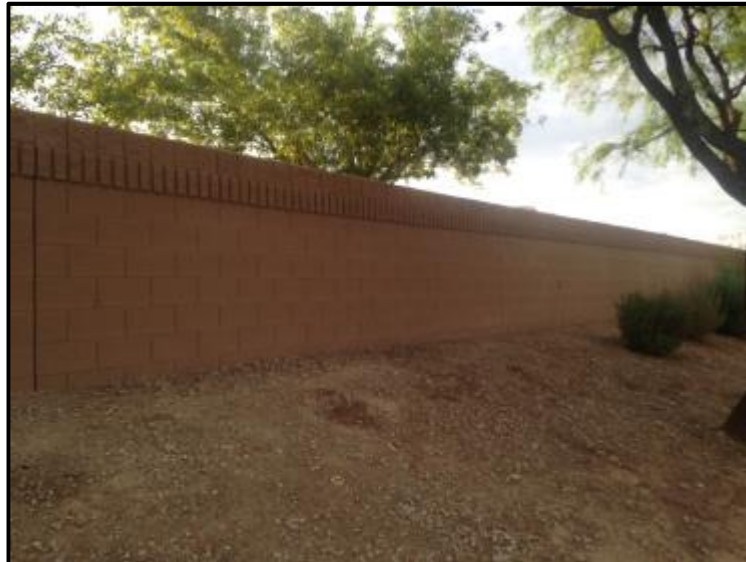
Age – Construction on this community began during late 2004 early 2005. Block walls installed during 2005.

Condition - During our onsite visit, we noted good to fair conditions. No signs of cracking or deterioration.

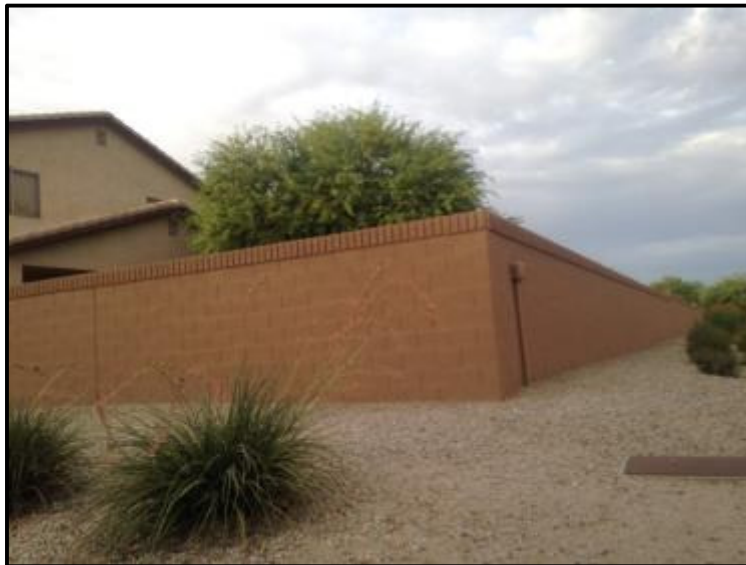
Age – The perimeter block walls were repainted during 2015 by Marcel Painting for approximately \$26,656.

Condition - During our onsite visit, we noted good conditions. No signs of peeling, cracking or chipping noted.

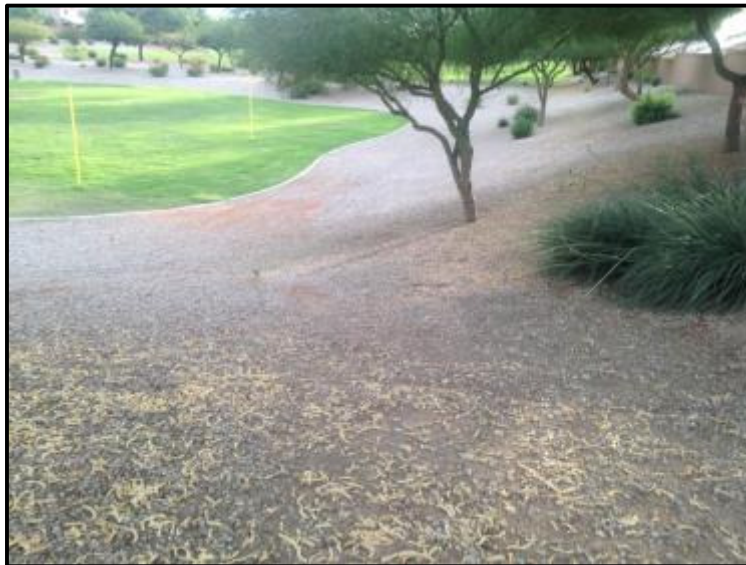
Landscape granite covers areas in the common area tracts. Conditions vary; some areas were noted to be sparse and thin. Recommend budgeting to replenish the landscape granite according to the table below.

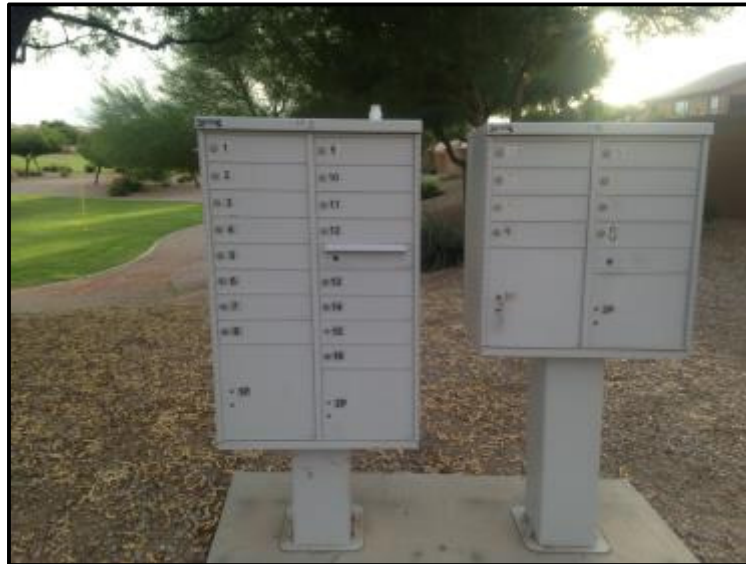
Age – These mailboxes were installed during late 2004 early 2005.

Condition - During our onsite visit, we noted good to fair conditions.

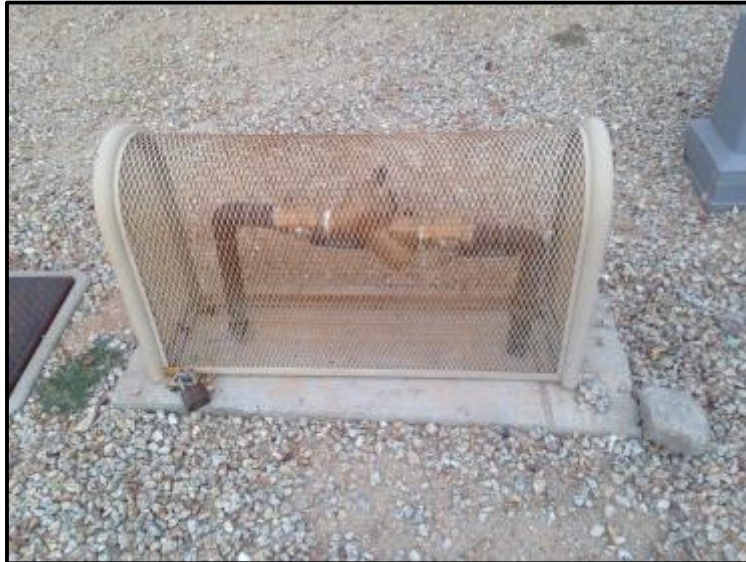
Age – Construction on this community began during late 2004 early 2005. These valves were installed during 2005.

Condition - During our onsite visit, we noted good to fair conditions. Appear to be functional and in good condition.

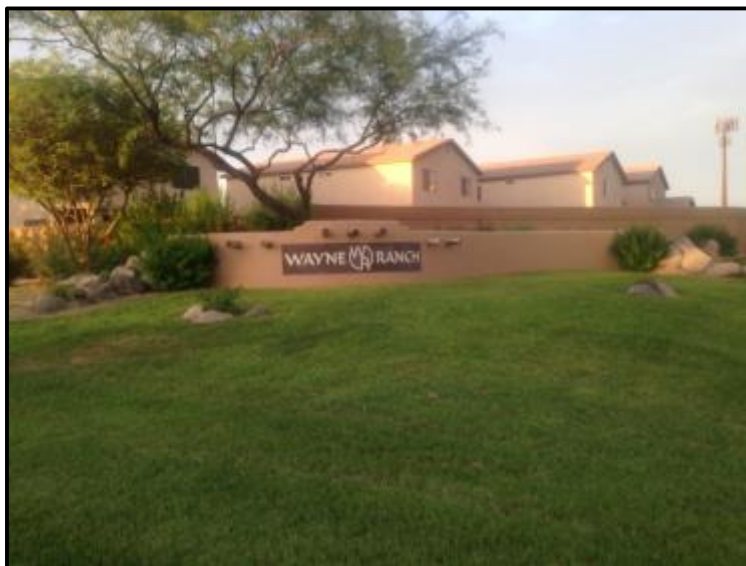
Age – Construction on this community began during late 2004 early 2005. This monument was installed during 2005.

Condition - During our onsite visit, we noted good to fair conditions. Monument consists of metal letters mounted to a stucco wall. This line item budgets to eventually replace the entry monument for aesthetic purposes.

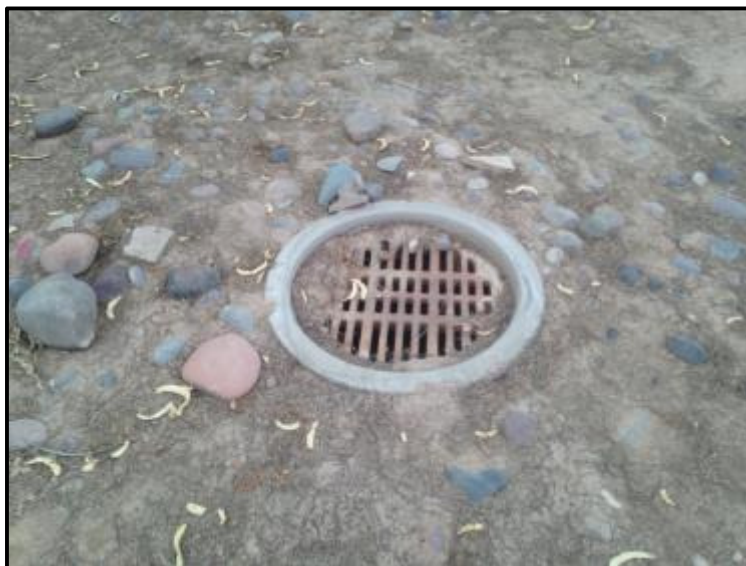
Age – Construction on this community began during late 2004 early 2005. Records not available of last cleanout.

Condition - During our onsite visit, we counted (7) drywells throughout the community. No observed or reported issues.

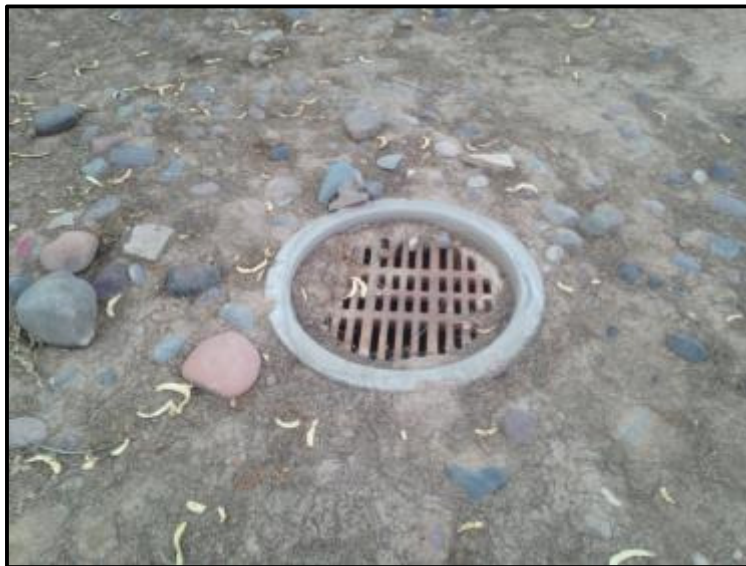
Age – Construction on this community began during late 2004 early 2005. These drywells were installed during 2005.

Condition - During our onsite visit, we counted (7) drywells throughout the community. No observed or reported issues.

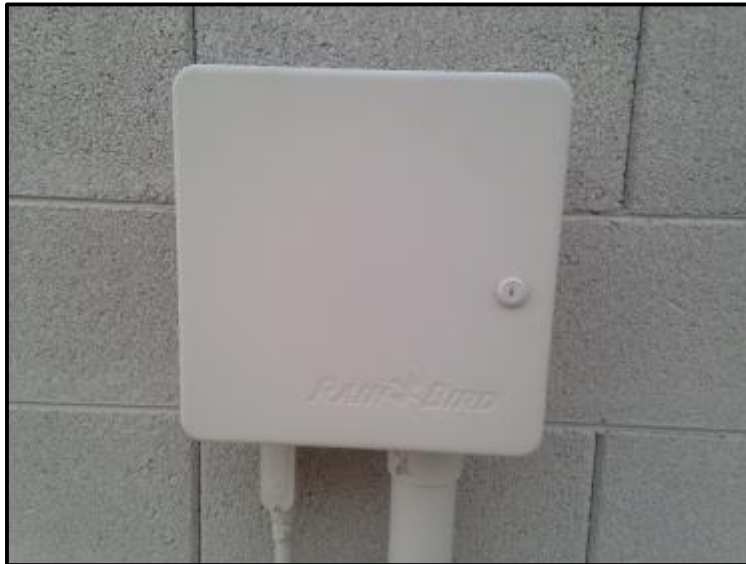
Age – Construction on this community began during late 2004 early 2005. Actual installation date of these controllers unknown at this time, we are assuming 2005 as the average installation date for budget purposes.

Condition – No reported or observed issues. Appear functional and in fair condition.

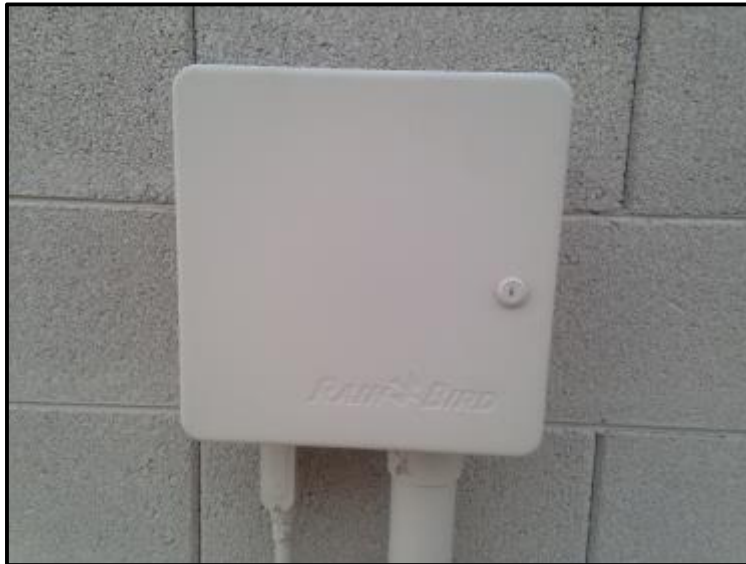
Age – This system was installed during late 2004 early 2005.

Condition – Major components of an irrigation system include underground elements, therefore we could not determine the remaining useful life of these components.

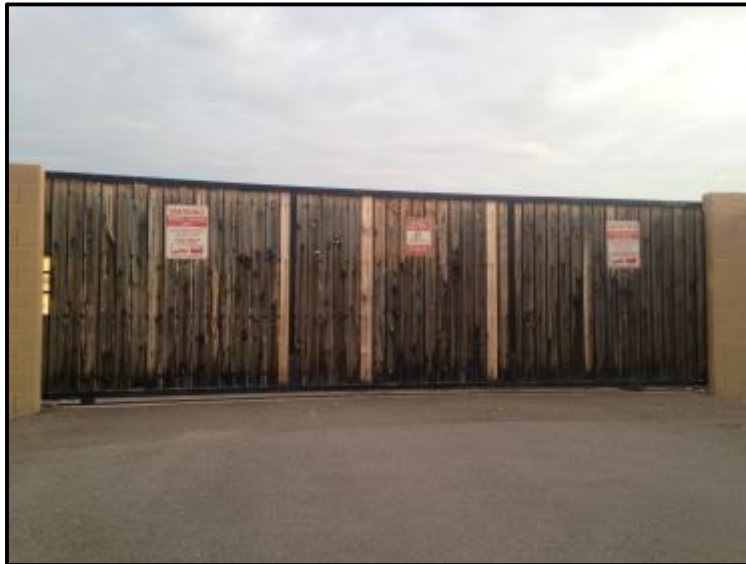
Age – These gates were installed during late 2004 early 2005.

Condition – These 25 foot rolling gates were observed to be functional and in fair condition.

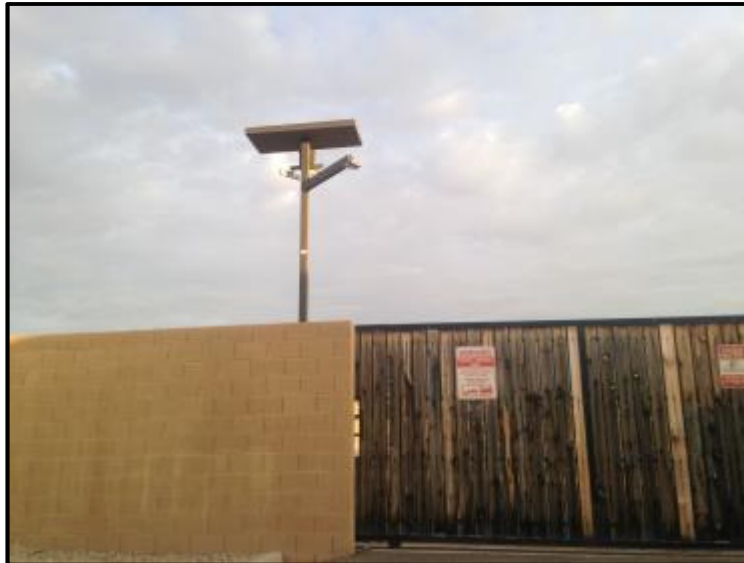
Age – These lights were installed during late 2004 early 2005.

Condition – Appear functional and in good condition. These lights will last up to 30 years due to the location.

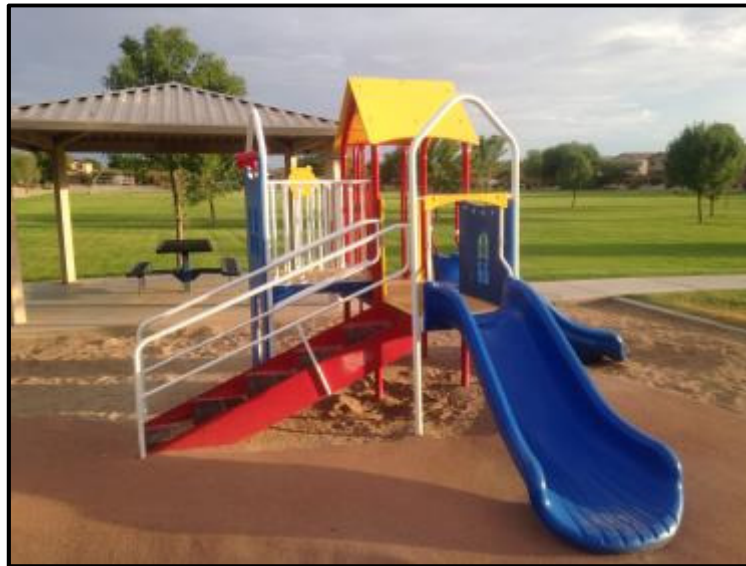
Age – These structures were installed during late 2004 early 2005.

Condition – Appear functional and in good condition. There are (4) smaller structures and (1) medium size structure located at each of the tot lots. We noted signs of graffiti during our inspection.

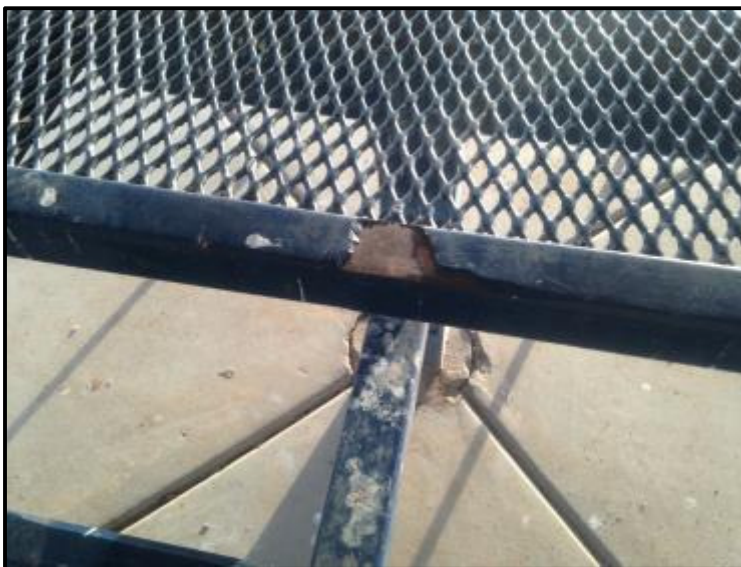
Age – The playground equipment was installed during late 2004 early 2005.

Condition – Some minor damage noted on the park furniture.

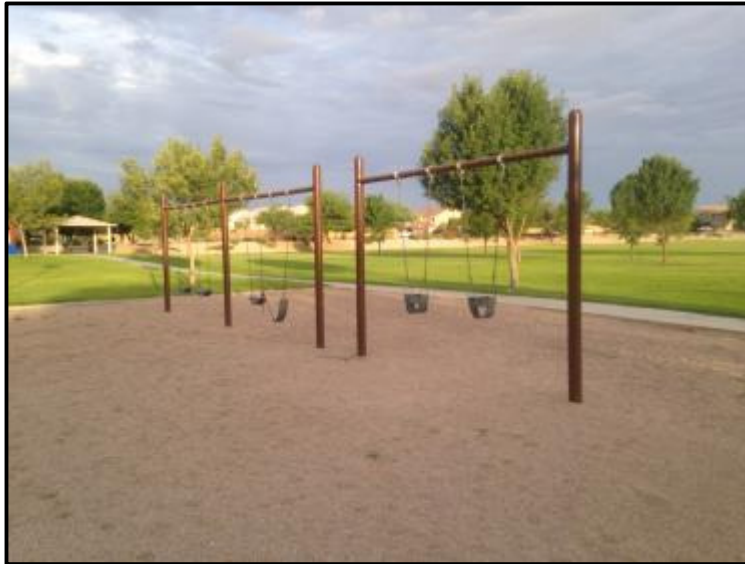
Age – This swing set was installed during late 2004 early 2005.

Condition – Swings intact and in good condition at the time of our inspection.

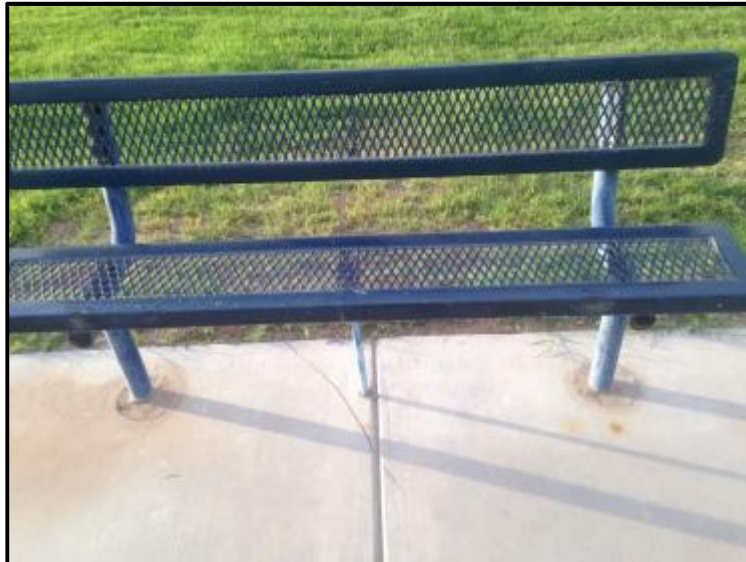
Age – These pieces were installed during late 2004 early 2005.

Condition – Some damage/vandalism noted. Overall fair conditions observed.

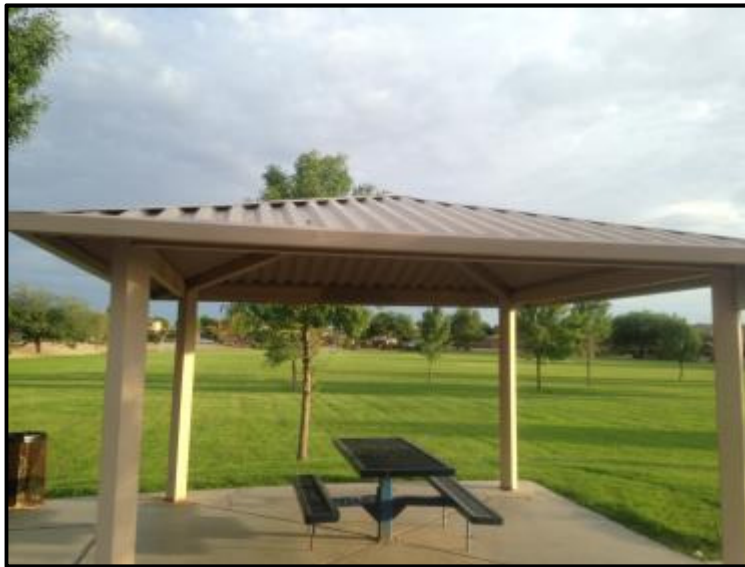
Age – These roofs were installed during late 2004 early 2005.

Condition – There (4) Ramada roofs located at the tot lots throughout the community. Roofs appear to be intact and in good condition. Metal roofs have a useful life up to 40 years.

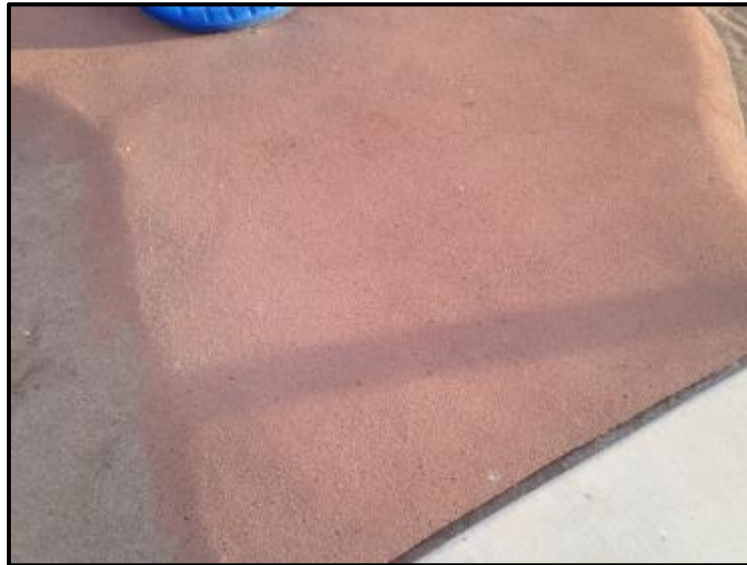
Age – These surfaces were installed during late 2004 early 2005.

Condition – We noted some separation and loose granules of the turf at the time of our inspection. There is approximately 480 gross square feet of tot turf in total.

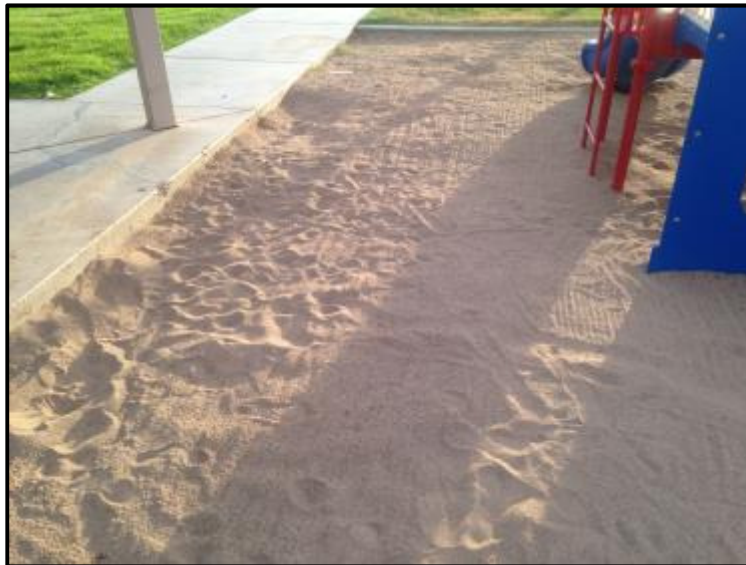
Age – Date of last replenishment unknown.

Condition – This sand is located at each tot lot and volleyball court. The sand was noted to be in overall fair condition.

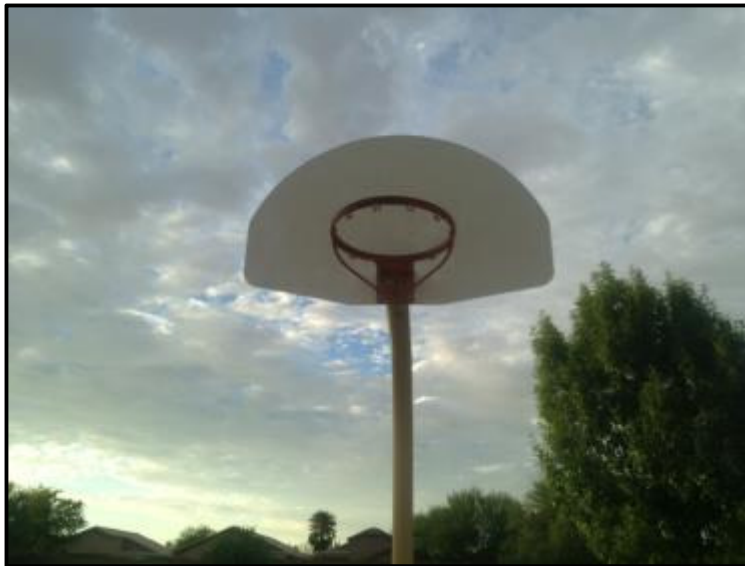
Age – These standards were installed during 2005.

Condition – These are in-ground mounted, fan-shaped standards. This is a long-life component under normal circumstances. No damage noted.

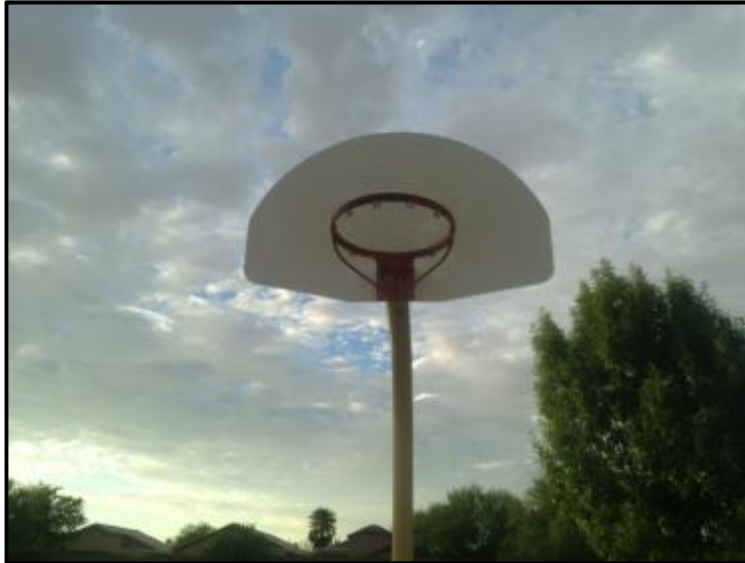
Age – These hoops were installed during 2005.

Condition – No damage noted to the metal rims. Good conditions observed.

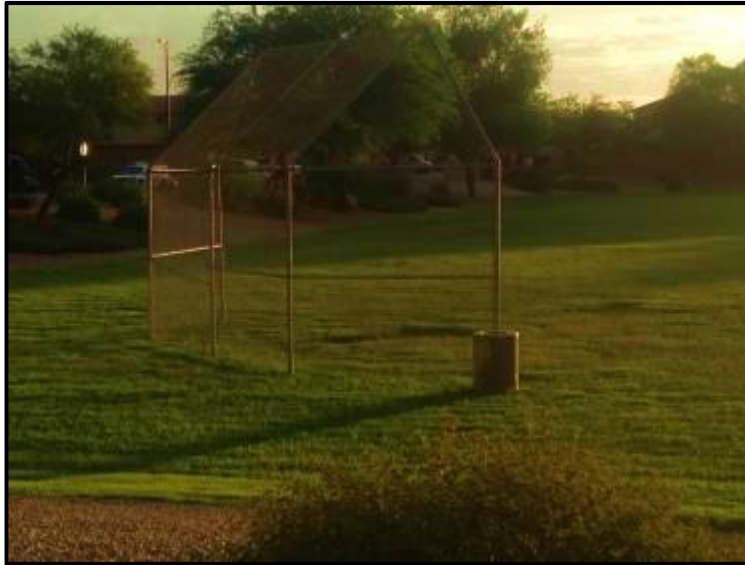
Age – This backstop was installed during 2005.

Condition – No damage noted to backstop. Good conditions observed.

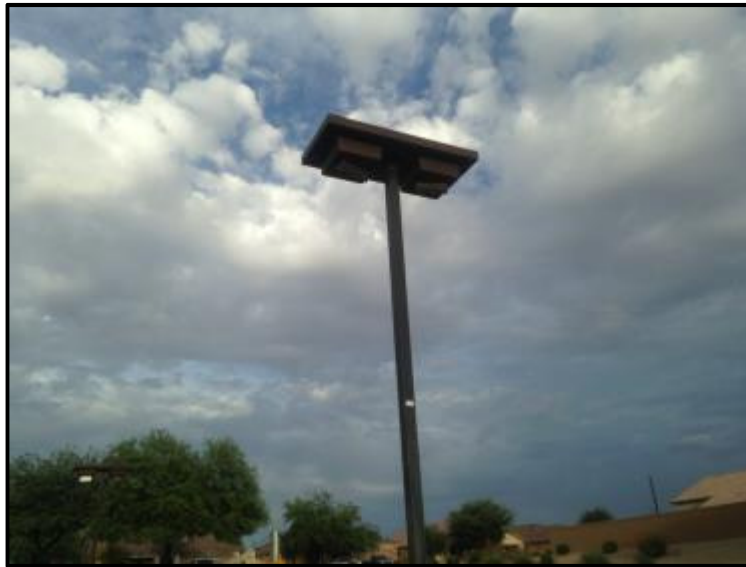
Age – These lights were installed during 2005.

Condition – These are SolarKing light poles. Some fading noted, however no major deterioration observed.
