RESERVE STUDY

EL TOVAR CONDOMINIUMS HOMEOWNERS ASSOCIATION HOMEOWNERS ASSOCIATION

November 13, 2018

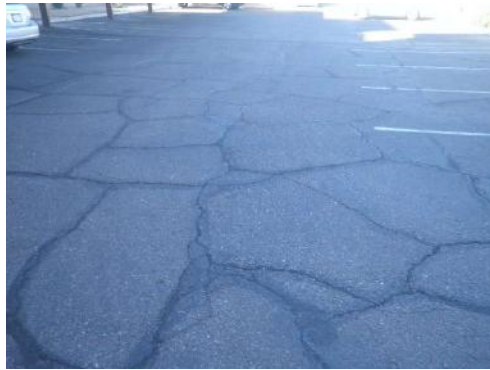
Poor condition. Recommend crack seal with slurry seal due to cracking and deterioration around valley gutter. One time asset to be followed by surface treatment the following year.

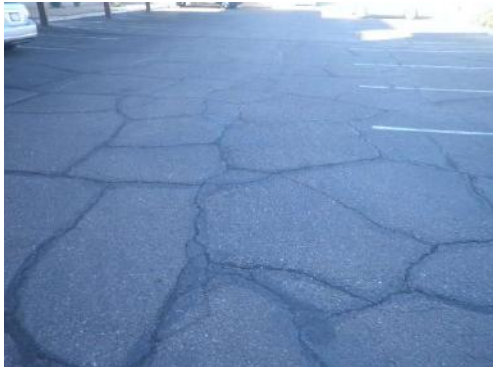
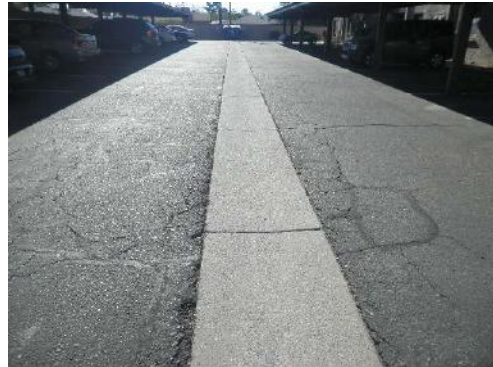
Asphalt - Remove & Replace continued...

Poor condition. Recommend crack seal with slurry seal due to cracking and deterioration around valley gutter. One time asset to be followed by surface treatment the following year.

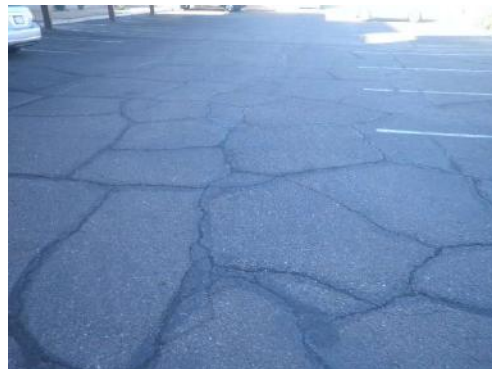
Poor condition. Recommend HA5 (high density mineral bond) for surface treatment as it does not track into condos, warranty for 5 years (lasting around 7 - 8 years) and holds color.

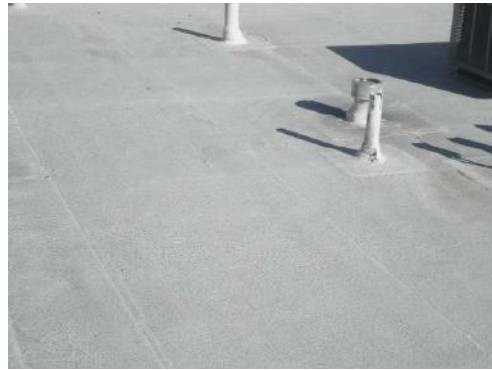
Good condition. Some chipping/peeling noted. Roof is tar based and elastomeric coated. Recommend inspection by professionals to determine if foam roof should be replaced and not just coated.

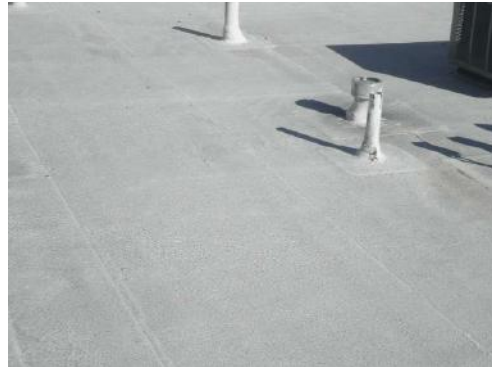
Foam Roof - New Foam continued...

Good condition. Some chipping/peeling noted.

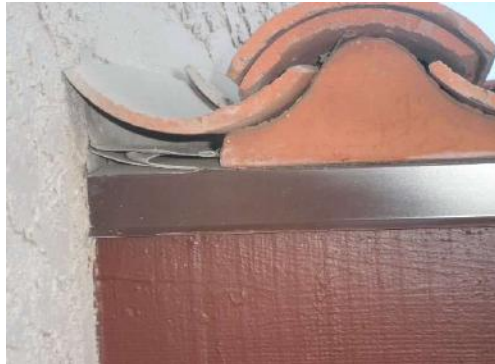
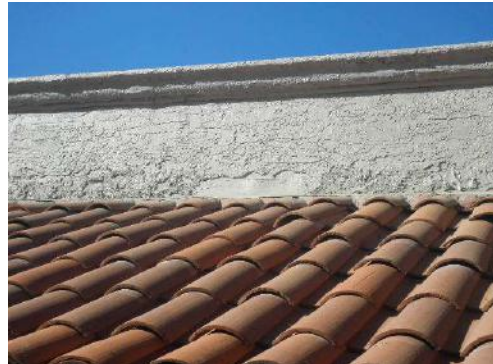
Good condition. Hayes Roofing, Inc install (2) layers of MBTech TU43 tile underlayment installed in 2015.

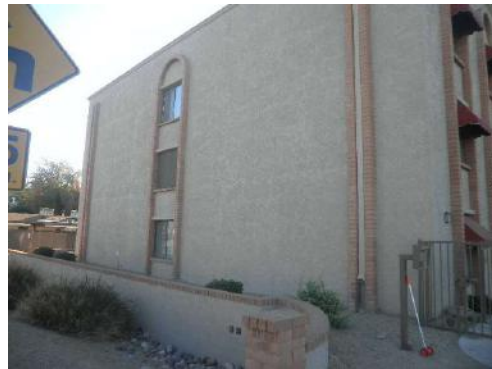
Good condition. Unforgettable Coatings repaint on 12/6/2016 included: all inclusive stucco, drywall, railings, carports, gates, entry doors and perimeter fencing.

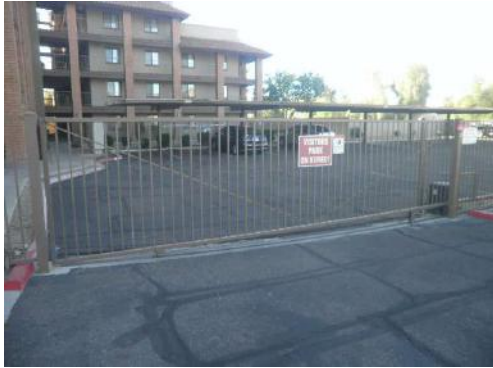
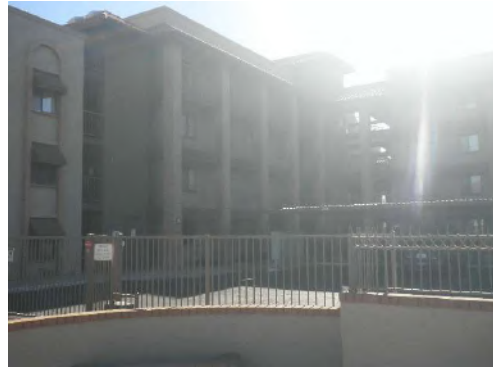
Good condition. (2) 6' X 24' sliding gates + (1) 4' pedestrian gate. The useful life of this asset has been extended due to its present condition.

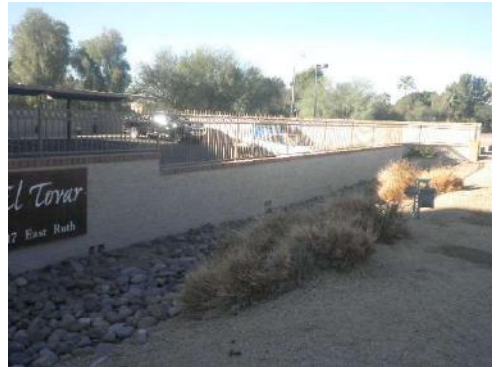
Perimeter Metal Railings - Replace continued...

Good condition. Unfunded but future updates should reflect a site visit and if any needed repairs have arisen. Approximately 330 SF of perimeter metal railings.

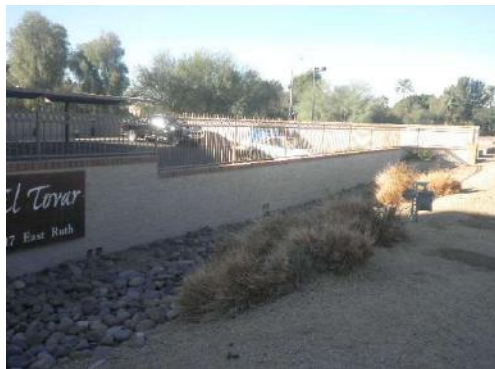
Good condition. This asset is for repairs of \$1000 every 5 years based on the condition. Approximately 840 SF - 4' high painted stucco block wall on north side, 1,470 SF - 7' high dooley wall on east side and 2,760 SF - 6' high painted stucco block wall on west and south side

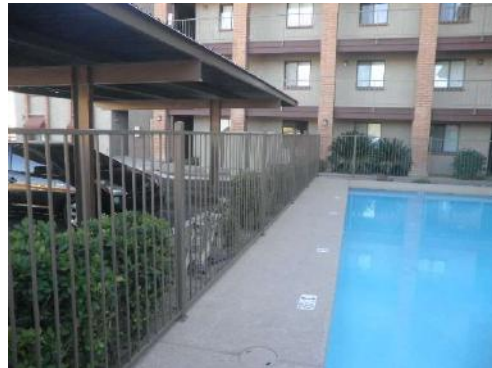
Good condition. Approximately 745 SF. This asset is for \$500 every 2 years for pool fence repairs.

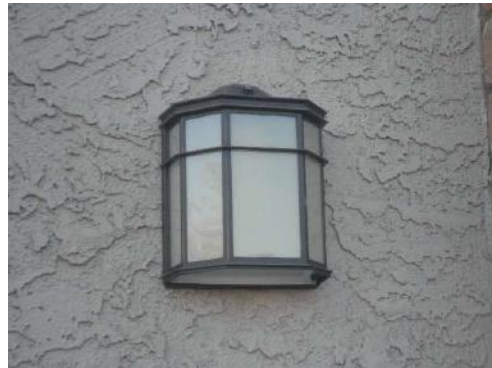
Good condition. The useful life of this asset has been extended due to its present condition.

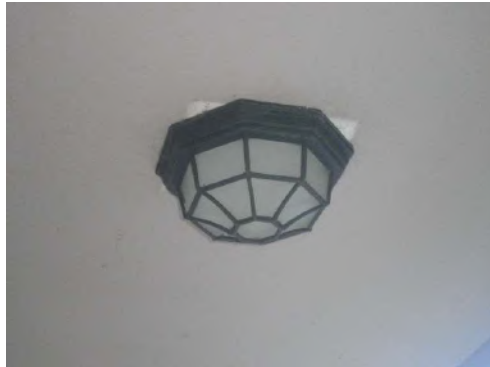
Ceiling Lights - Replace continued...

Good condition. The useful life of this asset has been extended due to its present condition.

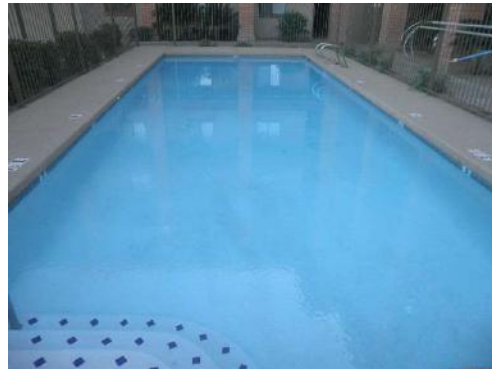
Fair condition. Chipping noted. Plaster pool. Approximate 955 SF. Acid wash was performed by Tropical Water Pool Service and Repair at end of 2015.

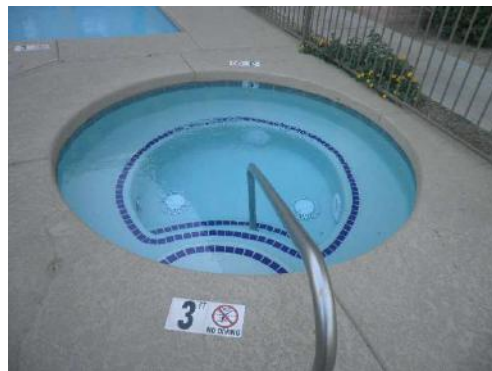
Good condition. Micro pebble surface.

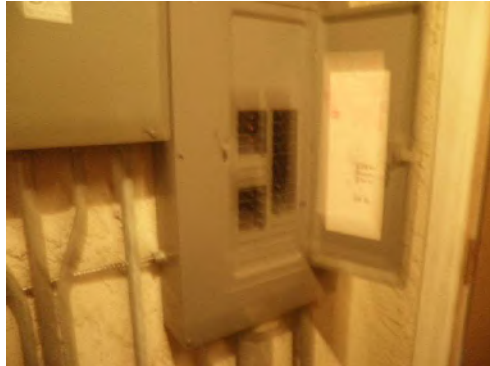
Electric Panel - Replace

Working condition. Located inside mechanical room.

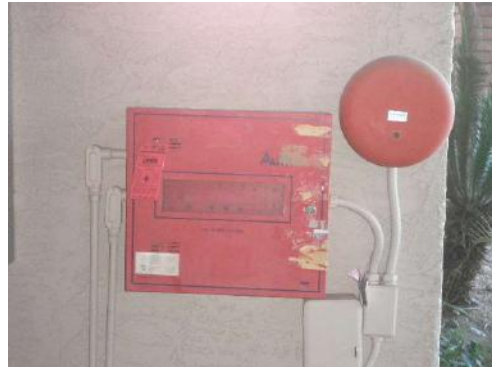
Fire System - Inspect continued...

Located outside on building. Auth Comp Model 100.

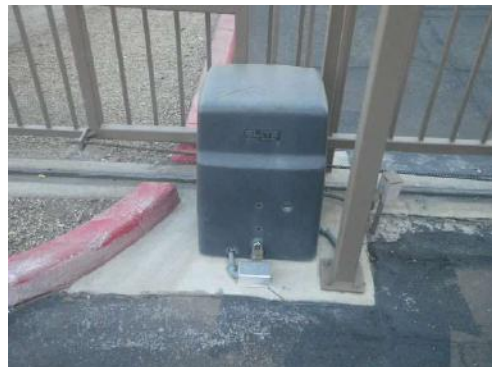
Working condition noted at site visit. (2) Elite gate operators 1/2 HP. The actual date this item was "placed in service" was not available. For budgeting purposes, we have estimated this date based upon its present condition.

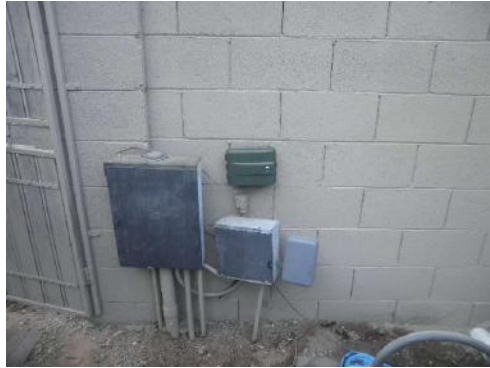
Irrigation Controller - Replace

Orbit. The actual date this item was "placed in service" was not available. For budgeting purposes, we have estimated this date based upon its present condition.

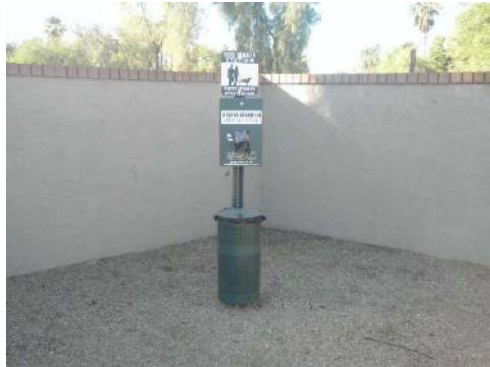
Pet Station - Replace continued...

Good condition. The actual date this item was "placed in service" was not available. For budgeting purposes, we have estimated this date based upon its present condition.

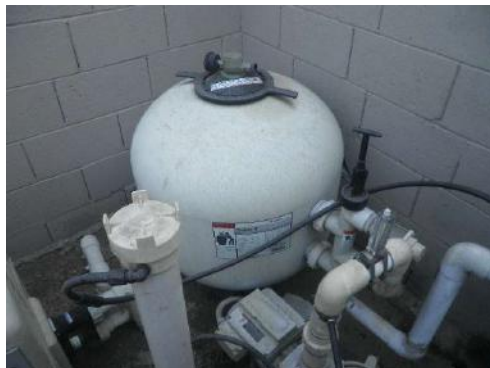
Working condition. Pentair Triton II TR100 mfg date 11/2011.

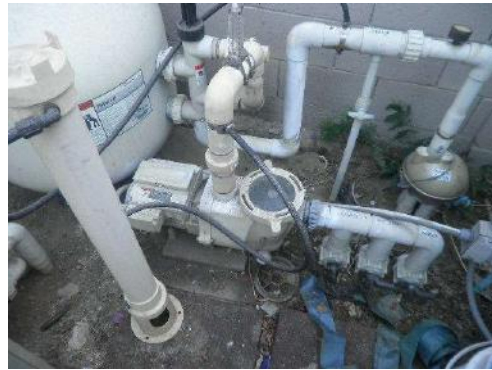
Working condition. This asset is for repair of pump and/or motor every 2 years for total \$500.
Pentair Whisperflo variable speed mgf date 9/2012 - replacement cost \$1400

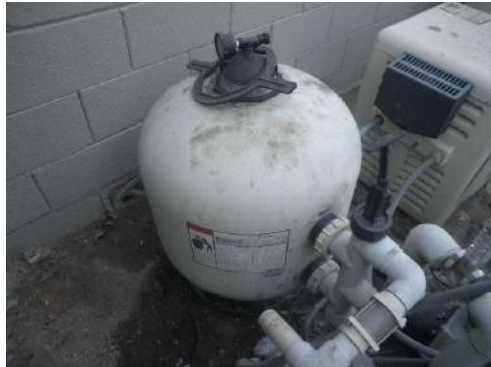
Spa Filter - Replace continued...

Working condition. Pentair Triton II TR60 mfg date 10/09.

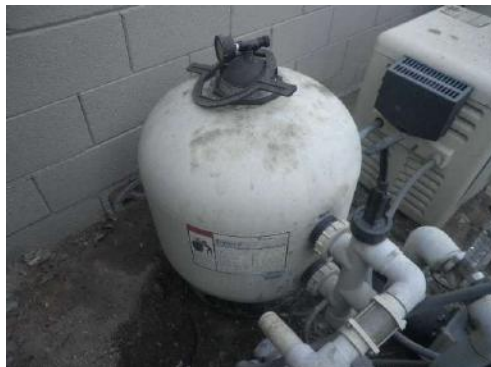
Working condition. Tropical Water Pool Service & Repair install Pentair Master Temp 400,000 BTU gas heater mfg date 8/2014 model # 460736 total \$3,058.

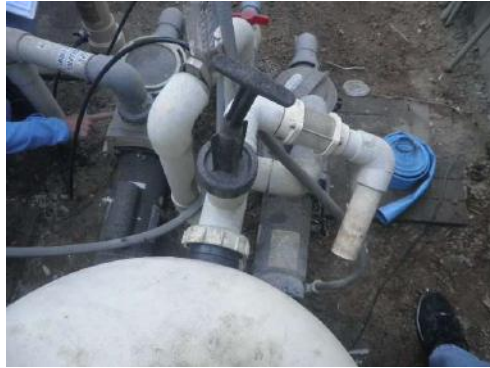
Spa Pumps & Motors - Repair

Working condition. This asset is for repairs to pumps and or motors every 2 years total \$1000.

Century 1 HP C48L2N134C2 no date - replacement price \$1000

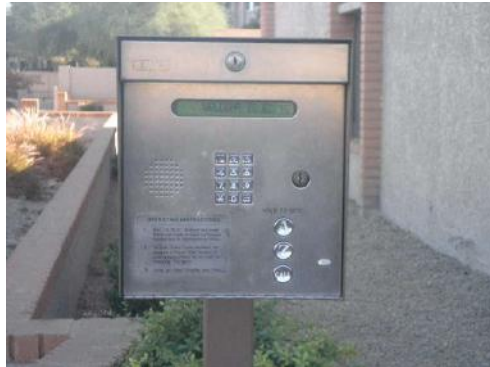
Telephone Access - Replace continued...

Working condition noted at site visit. DoorKing Systems telephone access keypad. The actual date this item was "placed in service" was not available. For budgeting purposes, we have estimated this date based upon its present condition.

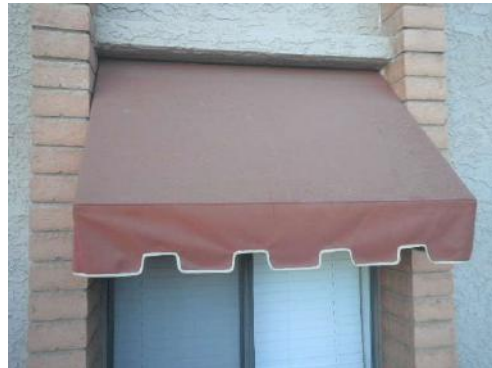
Fair to good condition. A couple are torn on trim. The actual date this item was "placed in service" was not available. For budgeting purposes, we have estimated this date based upon its present condition.

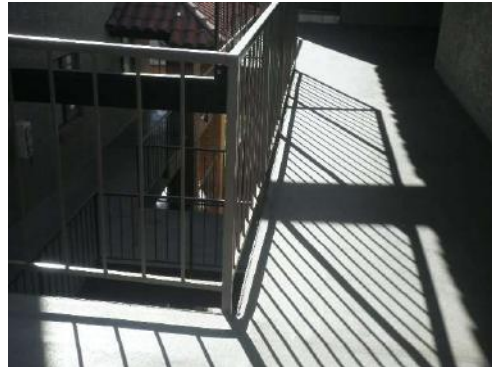
Building Metal Railings - Replace/Repair continued...

Good condition. This asset is for \$2,000 every 5 years for replacement or repairs to metal railings.

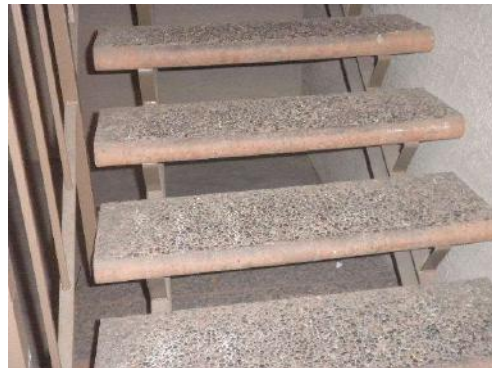
Good condition. Exposed aggregate concrete steps. Saw replacements in storage. Unfunded.

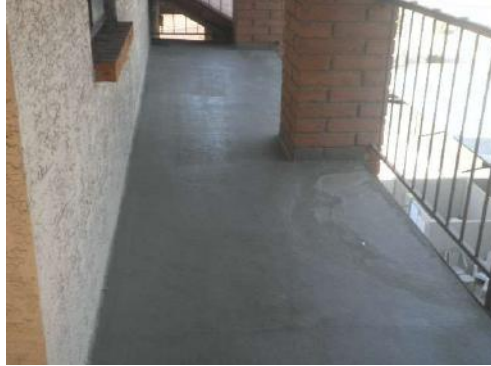
Walking Decks - Coat

Good condition. Per the Association, this asset has never been coated so it is unfunded. If the Association wishes to add in study please advise.

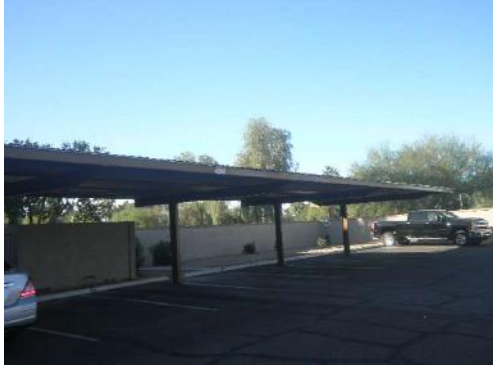
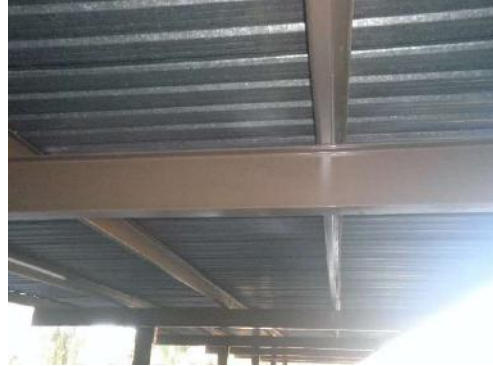
Good condition. All steel supports with corrugated metal roof. Painted support structures. Unfunded as this asset should last lifetime of condominium. Minor repairs, as needed, may be covered by the operational budget, operational contingency or insurance. Should the client feel otherwise, we will be happy to incorporate this element into our analysis.

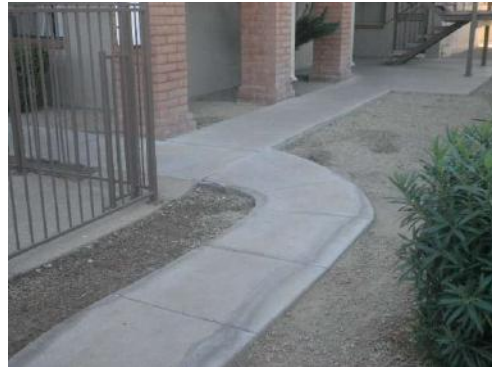
Concrete Components - Repair continued...

Good condition. Unfunded no notable tripping hazards noted.

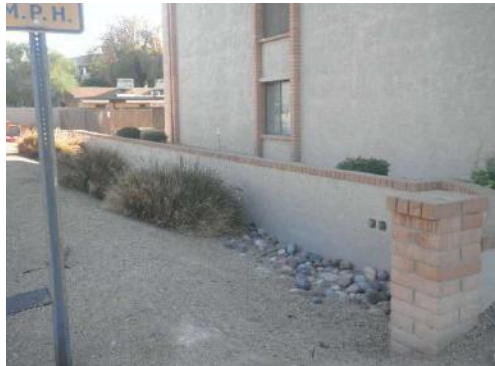
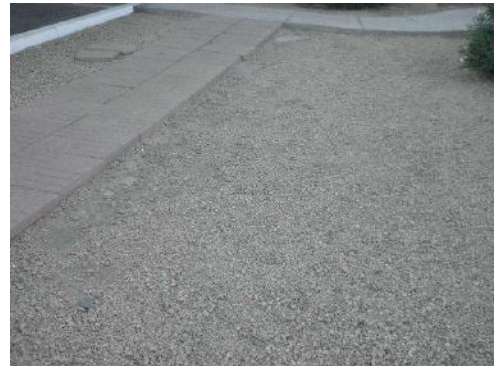
Poor condition. Recommend replenishment. This asset is approximately 10,000 SF or around 40 ton for 1.5" coverage.

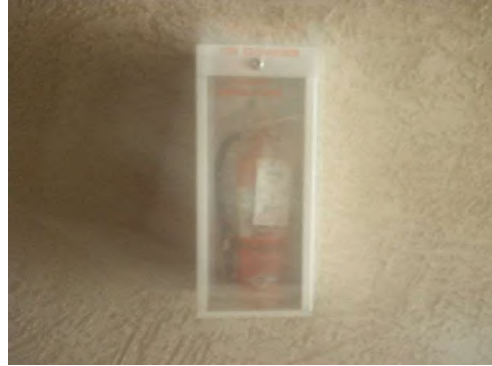
Fire Extinguisher Boxes - Replace

Good condition. Unfunded should last lifetime. If damaged, assuming repair would come out of operating budget. (12) units located on all floors and different locations under building cover.

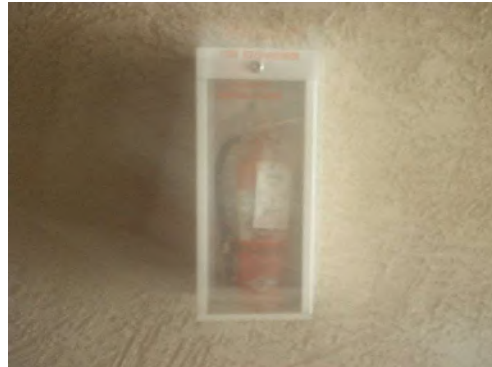
Fire Extinguishers - Inspect continued...

This asset is for yearly inspections of fire extinguishers located on residential buildings.

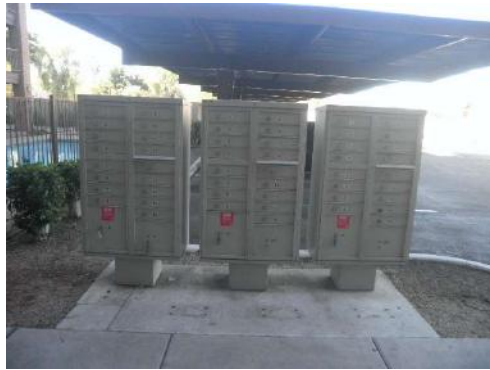
Mailboxes - Replace

Good condition. The actual date this item was "placed in service" was not available. For budgeting purposes, we have estimated this date based upon its present condition.

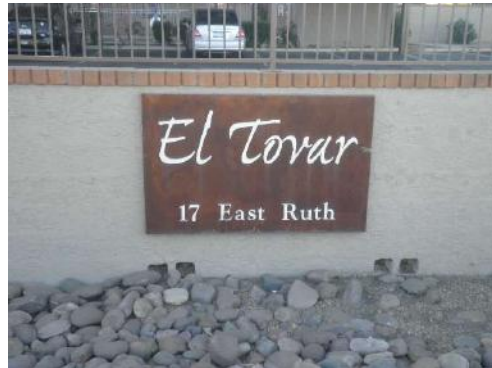
Good condition. Approximately 5 X 3.2 metal letter sign "El Tovar 17 East Ruth". Lettering needs white paint. The useful life of this asset has been extended due to its present condition.
