"Full" Reserve Study

Pueblo at Andersen Springs Chandler, AZ

Report #: 13318-0

Date Prepared: January 28, 2018

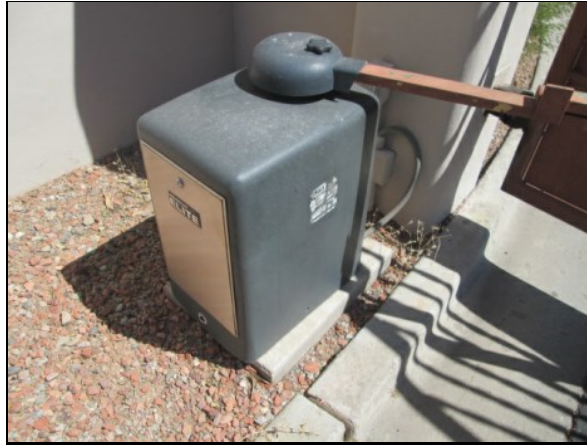
*Mfg dates from 10/2009 & 11/2009

Useful Life:
12 yearsRemaining Life:
3 years

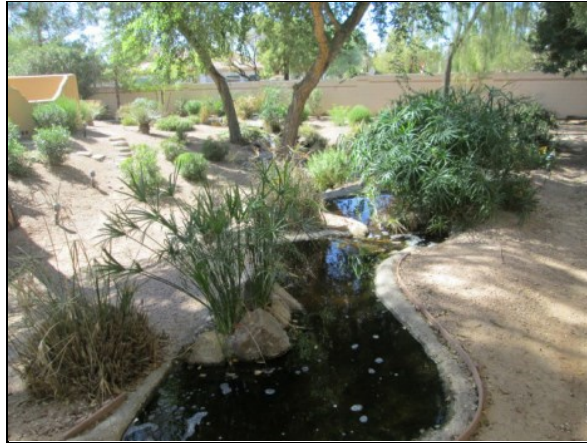
Evaluation: This component funds for future replacement of the decorative fountain that will be installed during 2021. Remaining life span is scheduled higher than the useful life, because the fountain does not exist yet.

Useful Life:
15 yearsRemaining Life:
18 years

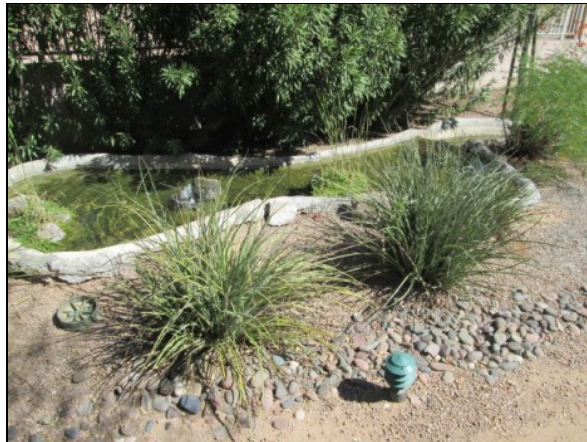
Evaluation: This component funds for future replacement of the decorative fountains that will be installed during 2018.

Useful Life:
15 yearsRemaining Life:
15 years

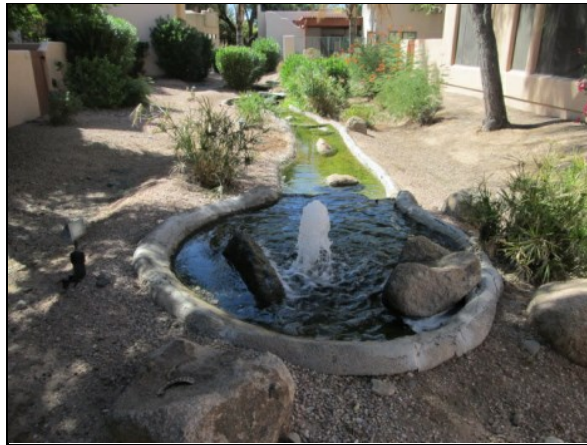
Evaluation: This component funds for future replacement of the decorative fountains that will be installed during 2020. Remaining life span is scheduled higher than the useful life, because the fountains do not exist yet.

Useful Life:
15 yearsRemaining Life:
17 years

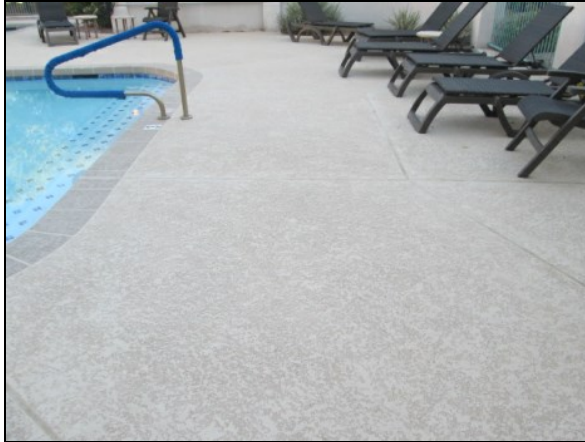
Comp #: 702 Pool Deck - Seal/Repair**Quantity: Approx 2,530 Sq Ft**

Evaluation: Pool decking appears in good shape with nice texture and minimal staining. This component funds to periodically patch cracks and seal/paint the deck to cover stains and restore the appearance.

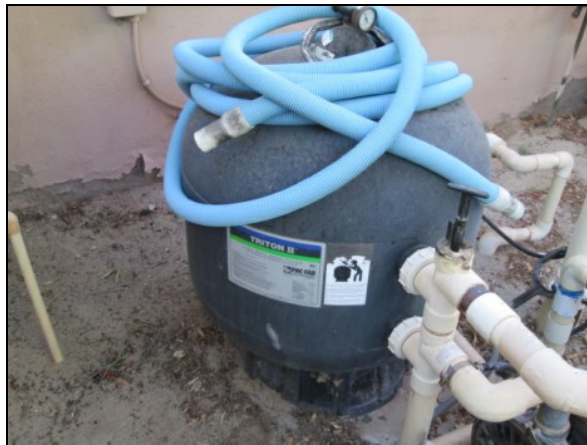
Comp #: 760 Pool Filter - Replace**Quantity: (1) Pac Fab, 4.91 Sq Ft**

Evaluation: Filter is older but functional. It has already exceeded the typical life expectancy. Replacement should be anticipated in the near future.

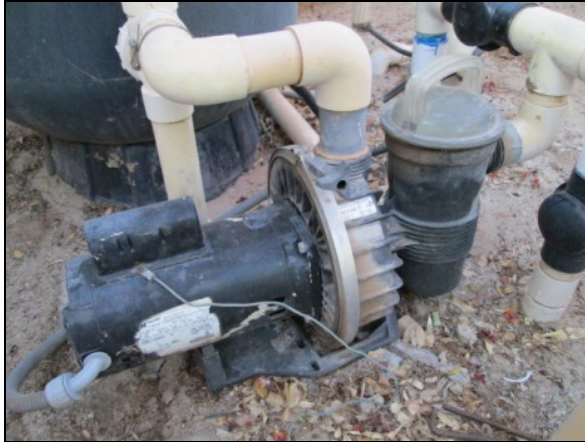
Comp #: 762 Pool/Spa Pumps - Replace**Quantity: (3) Pumps**

Evaluation: These pumps are all older. Still functional but should be nearing time for replacement. Periodic repair and motor replacement should be addressed as a maintenance issue. This component funds for replacement of the pump and motor assemblies.

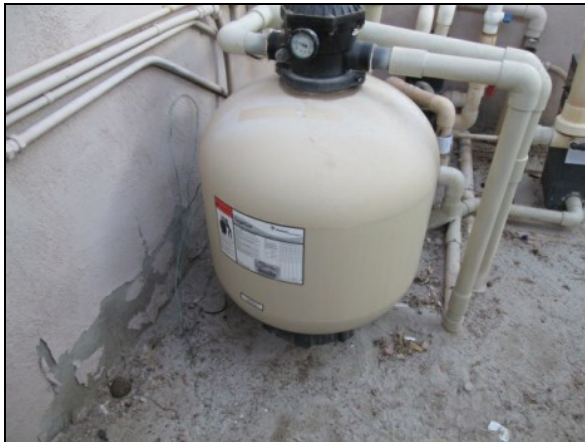
Comp #: 770 Spa Filter - Replace**Quantity: (1) Pentair Tagelus**

Evaluation: Filter appears to be in good to fair condition. No issues reported.

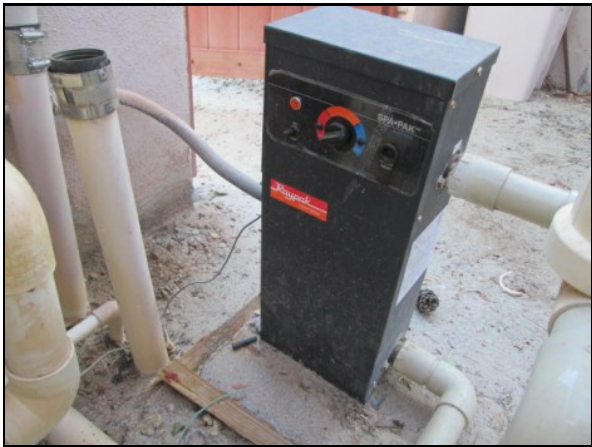
Comp #: 776 Spa Heater - Replace

Evaluation: This is a small, electric heater. It appears functional and in good condition. No issues noted.

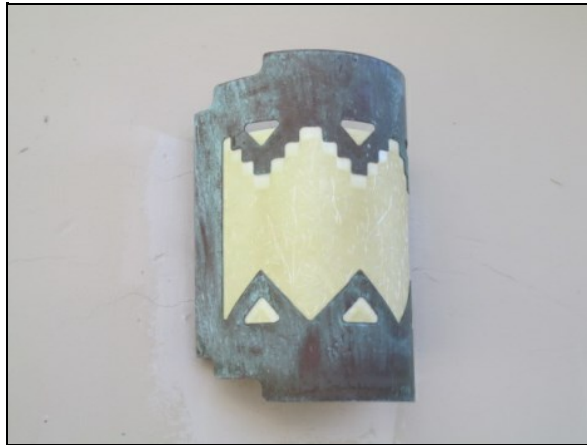
Comp #: 800 Light Fixtures - Replace

Evaluation: HOA is only responsible for light fixtures mounted at garages and common buildings. Lights vary in age, but they are all the same style. Still intact and in fair condition but getting older. Despite any age differences, HOA should plan complete replacement eventually to maintain uniformity throughout the community. Treat repairs and individual replacements as a maintenance expense.
