Update "With-Site-Visit" Reserve Study

Windmill Village HOA Buckeye, AZ

Report #: 19866-1
For Period Beginning: January 1, 2021
Expires: December 31, 2021

Date Prepared: December 2, 2020

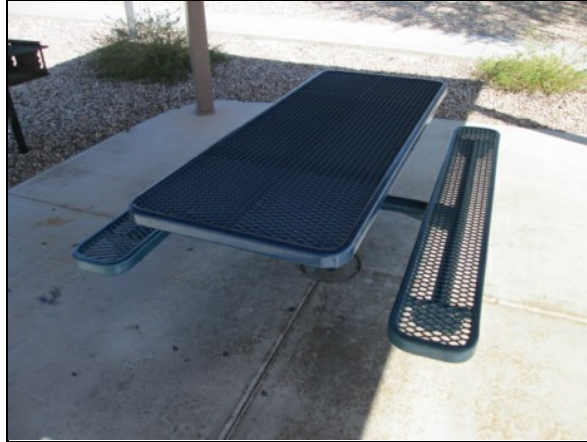
Comp #: 405 Park Furniture - Replace

History: Replaced in 2017. Previously original from around 2006.

Comments: Pieces include (1) 6' picnic table, (1) 6' bench, (1) trash can and (1) BBQ grill. Observed to be functional and in good shape.

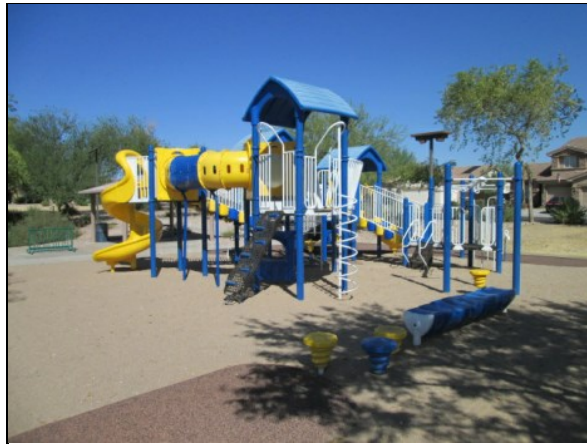
Comp #: 410 Playground Equipment - Replace

Comments: Pieces include (1) play structure and (1) 4-seat swing-set. Manufactured by Playworld. Normal wear and weathering evident. Future replacement should be anticipated.

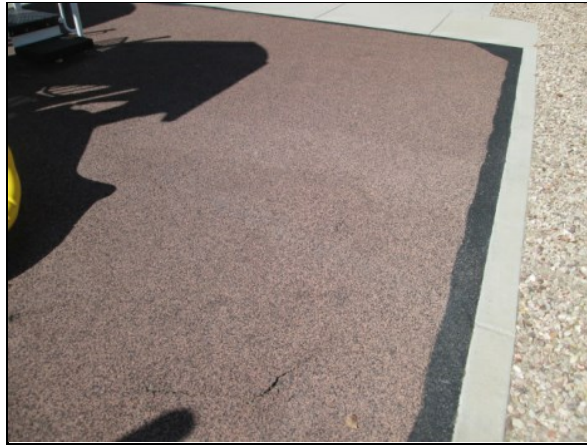
Comp #: 415 Playground Turf - Replace

History: Repaired in 2018. Original from around 2006.

Comments: This is a cushioned surface designed to help absorb a child's fall. It also provides better access to the play structures for handicapped children. Observed to older and getting stiff. Some cracks were also evident. Based on age, replacement should be expected soon.

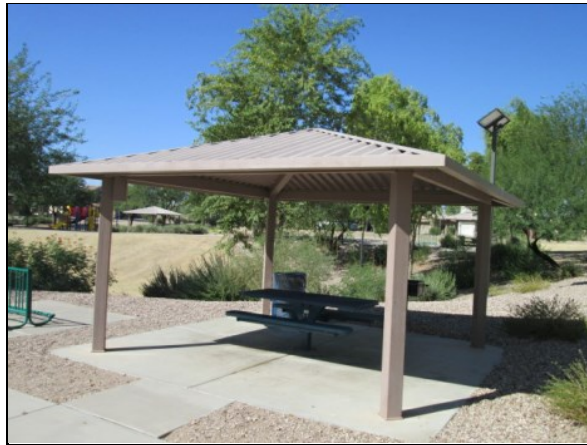
Comp #: 420 Ramada Roof - Replace

Comments: These ramadas have a standing seam, steel roof system. Long life expectancy under normal circumstances. Future replacement should still be planned, even if just for an aesthetic restoration.

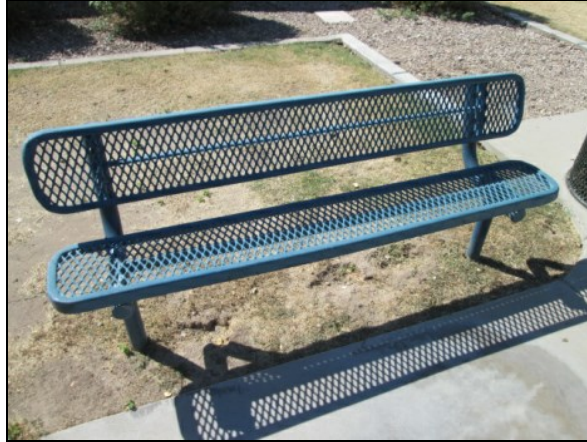
Comp #: 405 Park Furniture - Replace

Location: Playground on corner of Lasso Ln & 220th Ln
Funded?: Yes.
History: Installed around 2006.
Comments: Observed to be older, worn and weathered.

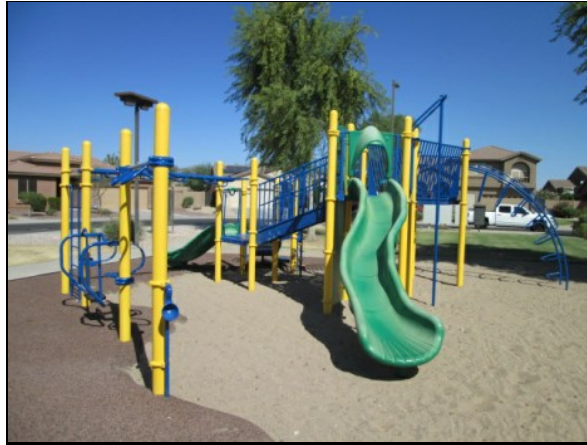
Comp #: 410 Playground Equipment - Replace

Comments: This is a play structure manufactured by Playworld. Normal wear and weathering evident. Future replacement should be anticipated.

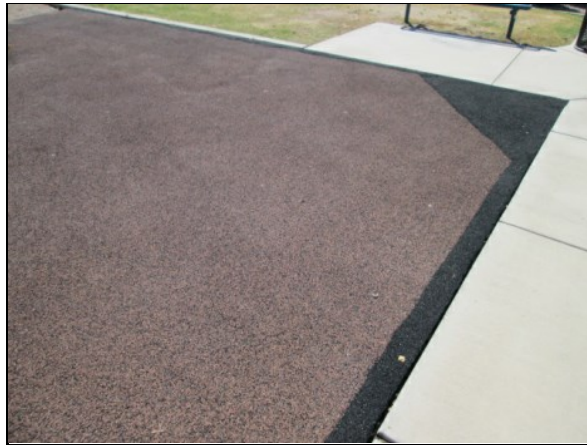
Comp #: 415 Playground Turf - Replace

History: Repaired in 2018. Original from around 2006.

Comments: This is a cushioned surface designed to help absorb a child's fall. It also provides better access to the play structures for handicapped children. Observed to older and getting stiff. Some cracks were also evident. Based on age, replacement should be expected soon.

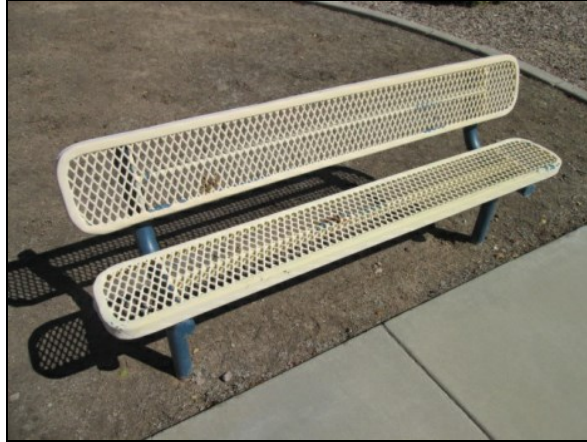
Comp #: 405 Park Furniture - Replace

Comments: Pieces include (1) 6' bench and (1) trash can. Observed to be older, worn and weathered.

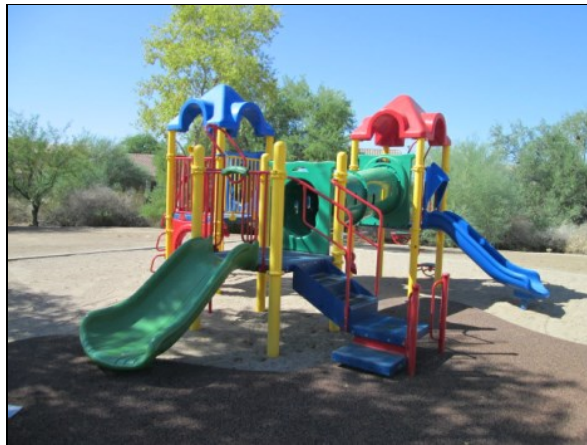
Comp #: 410 Playground Equipment - Replace

Comments: This is a play structure manufactured by Playworld. Normal wear and weathering evident. Future replacement should be anticipated.

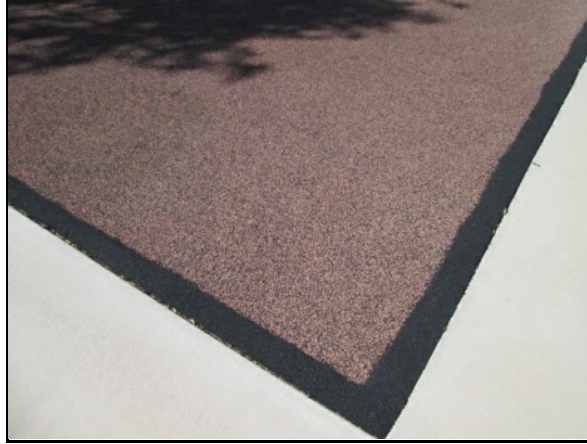
Comp #: 415 Playground Turf - Replace

History: Repaired in 2018. Original from around 2006.

Comments: This is a cushioned surface designed to help absorb a child's fall. It also provides better access to the play structures for handicapped children. Observed to older and getting stiff. Some cracks were also evident. Based on age, replacement should be expected soon.
